TECHNICAL SERVICE BULLETIN 7.3L - Various Electrical Concerns - Wiring Harness Contacting A/C Compressor Inlet Line

21-2198 28 June 2021

Ford Engine: 7.3L 2021 F-650/F-750

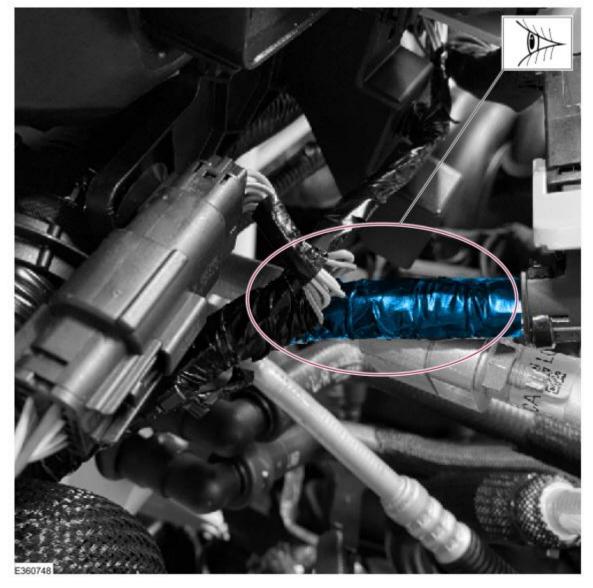
Issue: Some 2021 F-650/F-750 vehicles equipped with a 7.3L engine may exhibit various electrical concerns and/or various illuminated warning lamps with various diagnostic trouble codes (DTCs) present. This may be due to the powertrain control module (PCM) wiring harness contacting the air conditioning (A/C) compressor inlet line. To correct the condition, follow the Service Procedure to repair any damaged circuits and secure the PCM wiring harness to the main wiring harness.

3. Closely inspect the wiring harness for contact with the A/C compressor inlet line below the PCM. (Figure 3) Figure 3

- **4.** If any contact is noticed, carefully remove wiring harness sheathing. Repair all damaged circuits as necessary. Refer to Wiring Diagram, Cell 005. Wrap repaired section of wiring harness at least twice with Coroplast Electrical Wire Harness Tape.
- **5.** Cut the wire protection sleeve into four sections. (Figure 4)
